Mech

Summer 2007

THE NAVY & MARINE CORPS AVIATION MAINTENANCE SAFETY MAGAZINE

Vol. 46, No. 3 Summer 2007

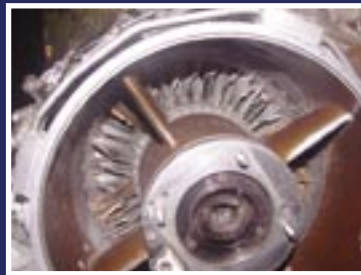
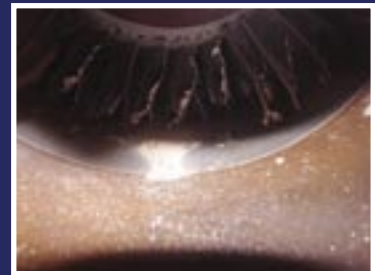
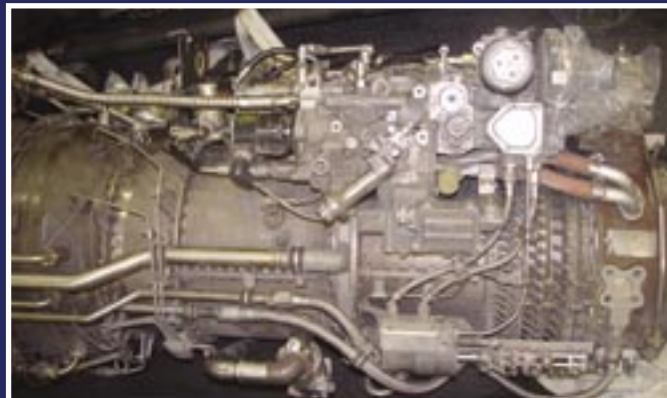
AVCM (AW/SW) Dave Clark, AIMD MMCPO, USS *Bataan*, sent these photos of FOD found in a T-58 engine from an H-46.

Dave commented, "We dropped off the Marines, and well...the sand seems to have won a round with the engine. Notice the peeling of the leading edges, and how the blades bent as the problem progressed. Notice the sand still in the intake. FOD wins."

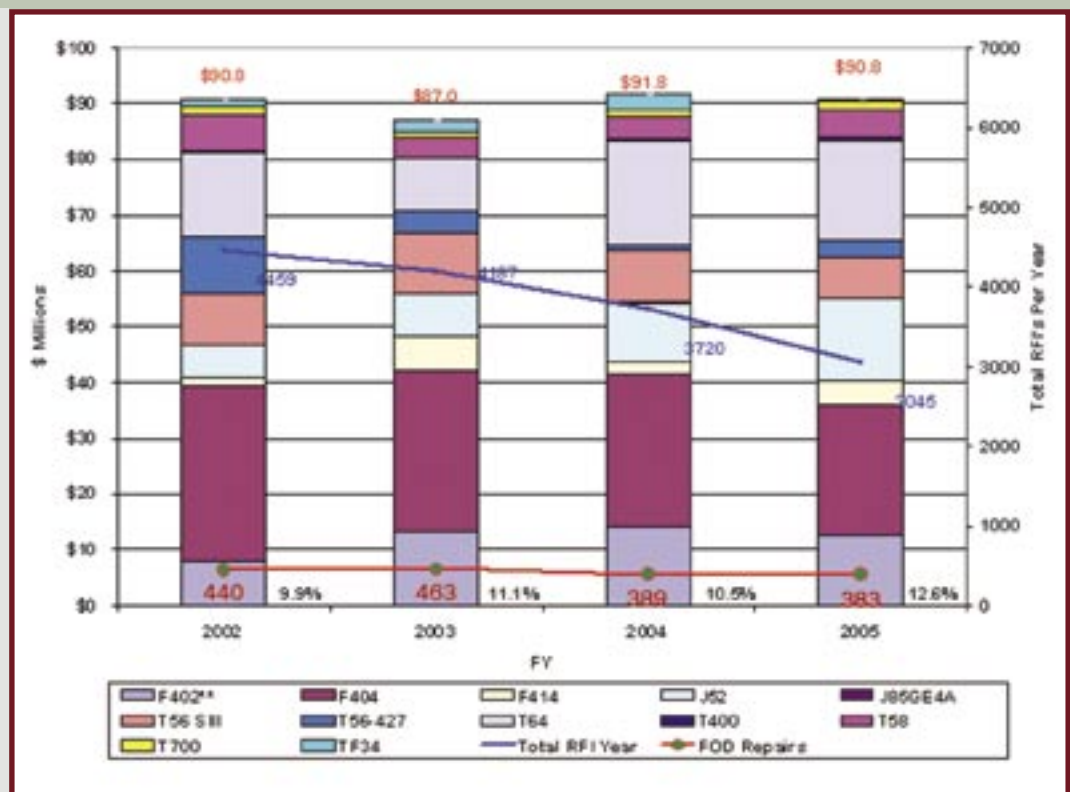
FOD Cost and Repair Chart Captures the Scale of the FOD Problem and the Challenge for the Way Ahead

The overall number of repairs has decreased (blue line) because of reliability improvements and "build goals" that have been implemented over the last few years. FOD repairs (red line) also have decreased, but the percent of repairs has remained fairly constant. The number of engines repaired after a reported FOD event does not include the engines that are still awaiting repair or have been stricken. At the end of FY-06, 103 engines and/or modules reported as removed for FOD were awaiting repair or disposition. Another 109 had been stricken. A new effort called FOD forensics holds great promise as a way to breakthrough and make a big difference in the fight against FOD.

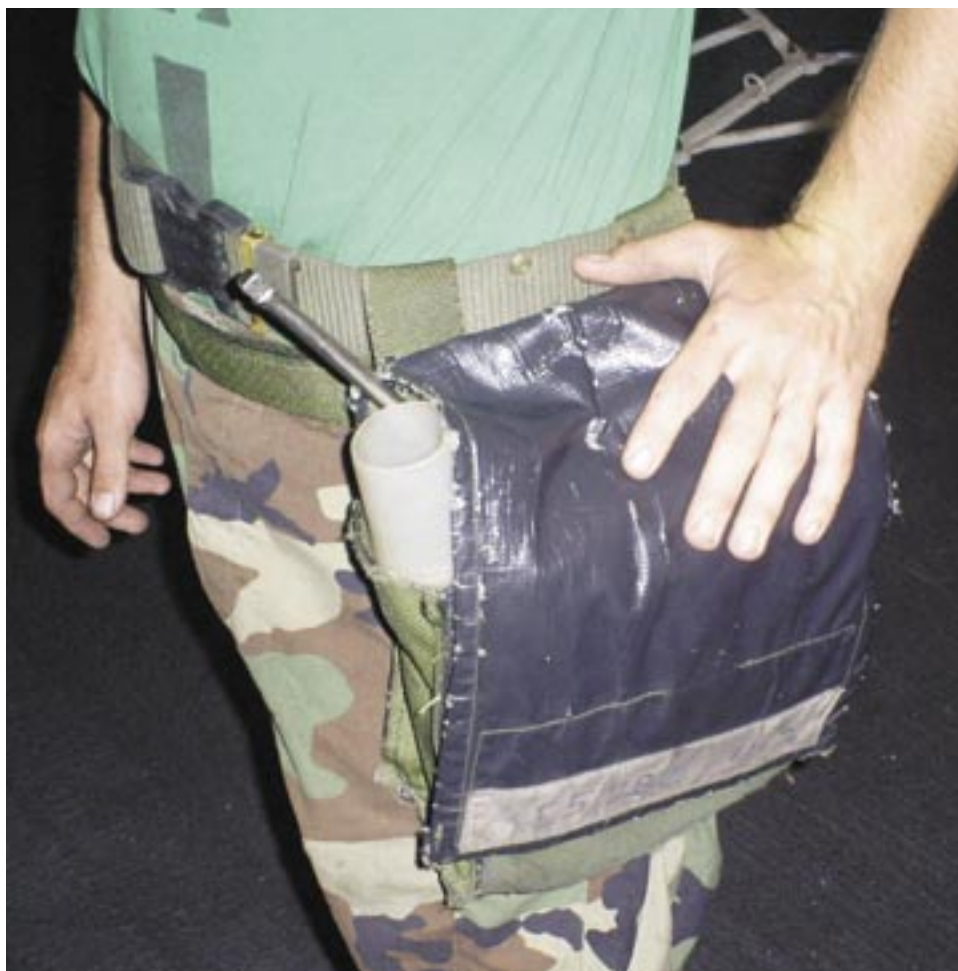
A good tool pouch and inventory procedures keep tools from becoming FOD.

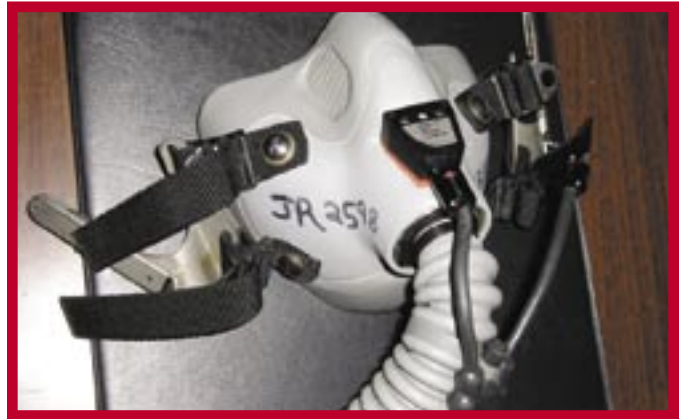
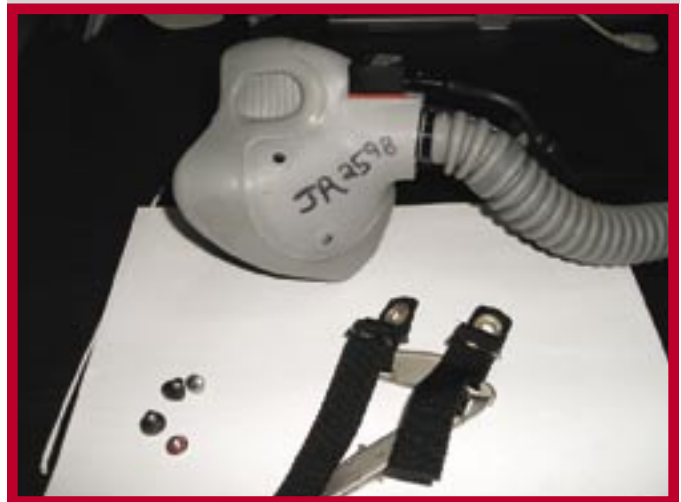
Top: pilot mask correct. Bottom: bayonet off

- The mask could have come apart while at high altitude, causing hypoxia.
- The screws could have jammed the flight controls, resulting in the loss of the aircraft and possibly the pilot.
- During high-speed combat maneuvers, the mask could have become a missile hazard inside the cockpit.

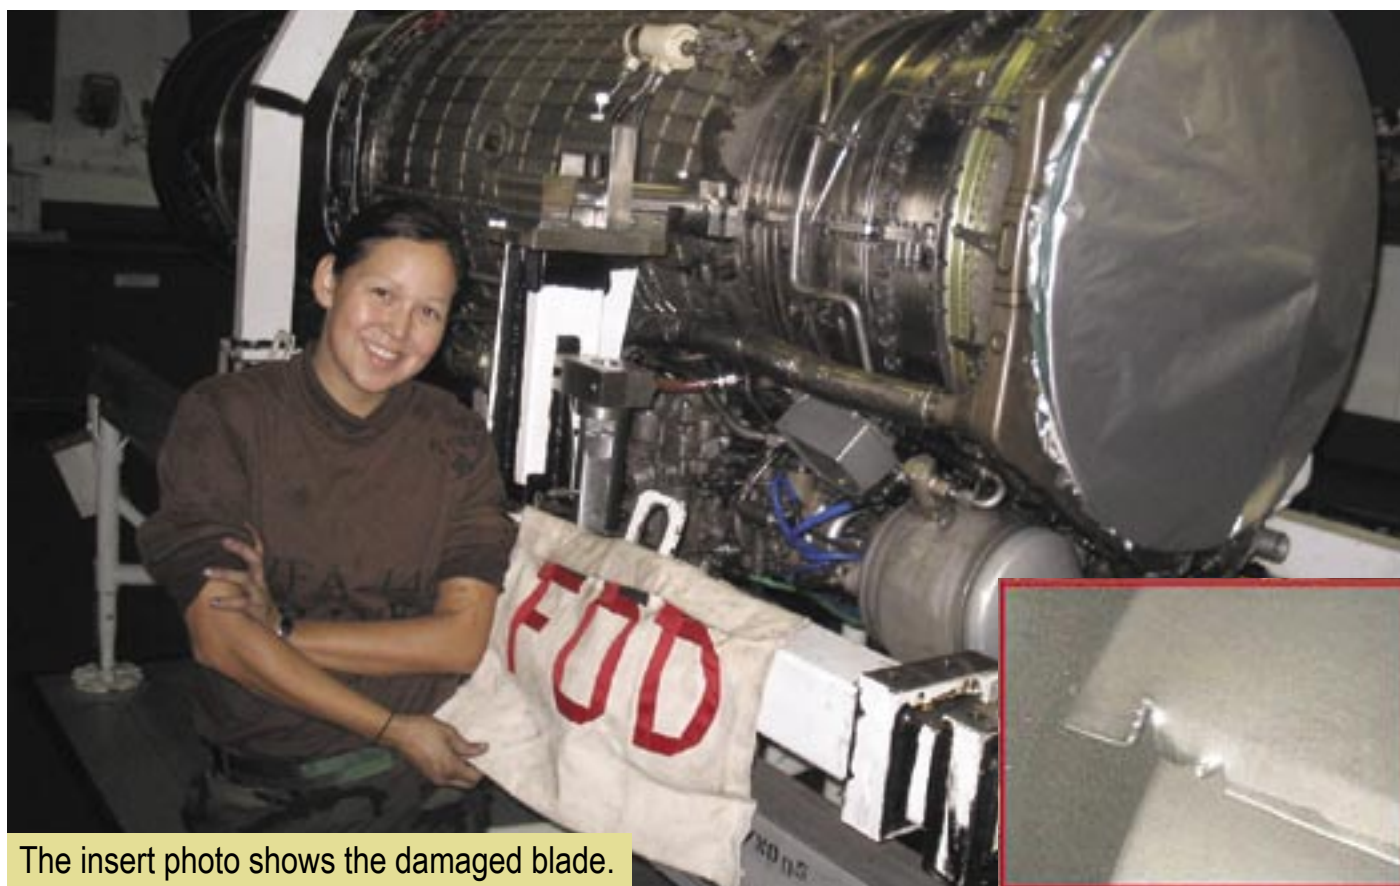
I then “dove” the port intake duct and suddenly noticed the port engine had damaged blades from FOD!

The insert photo shows the damaged blade.

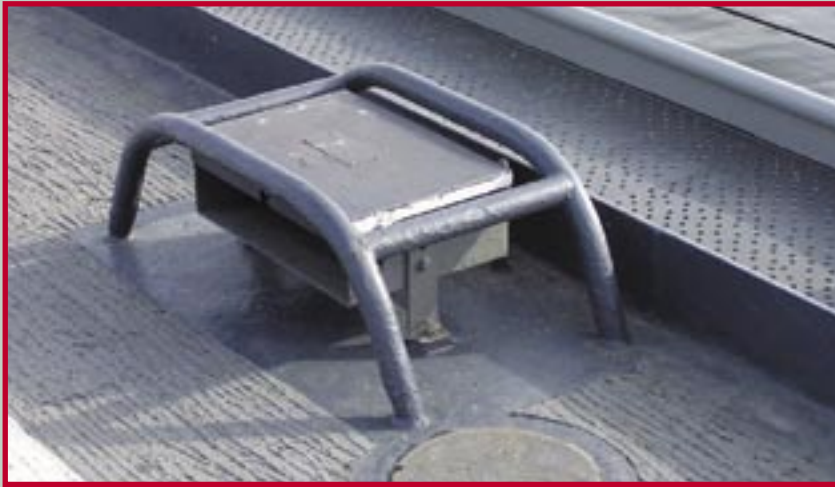
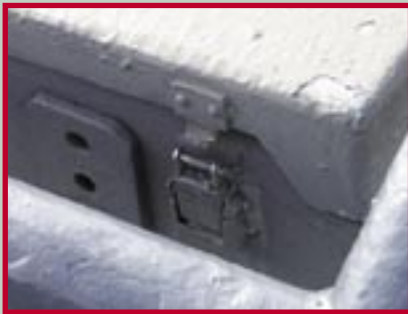
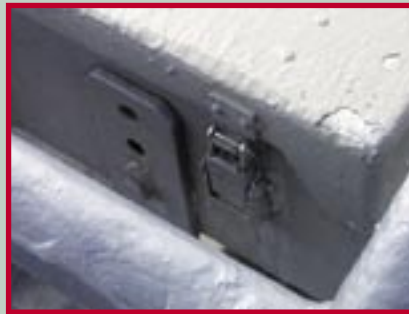
A FOD check should include security of gear on and around the deck. A close look shows the latch on this light housing can be critical.

I held off the two helicopters into the Delta holding pattern until my deck crew could investigate. They found that the unsecured light cover had been blown off by the H-47's rotor downwash during the initial landings. The missing cover allowed light to escape the housing and reflect off the deck coaming. Once the deck crew

We learned a cheap lesson that night because nobody was hurt and nothing was damaged. We since have added a security "pull" on these light covers as part of our FOD walkdown. This security step was adopted because the latches on the light covers may appear to be secured when they merely are resting in the down position. Therefore, a visual inspection is not enough, especially if the check is done in low-light conditions. Finally, I have

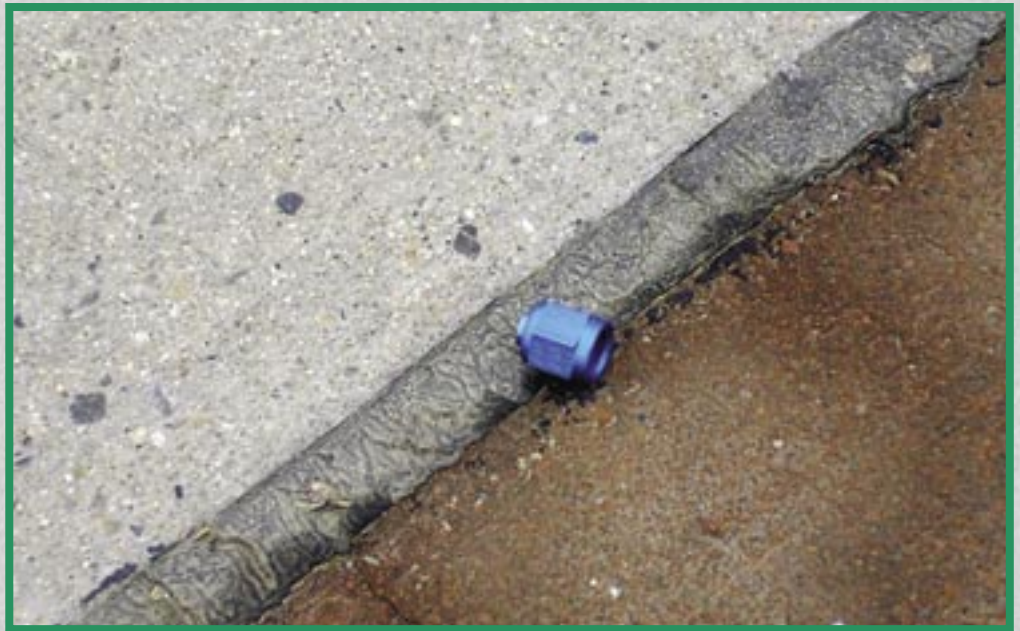
Ugly

This hydraulic line found laying on the ground and in dirt is a serious problem.

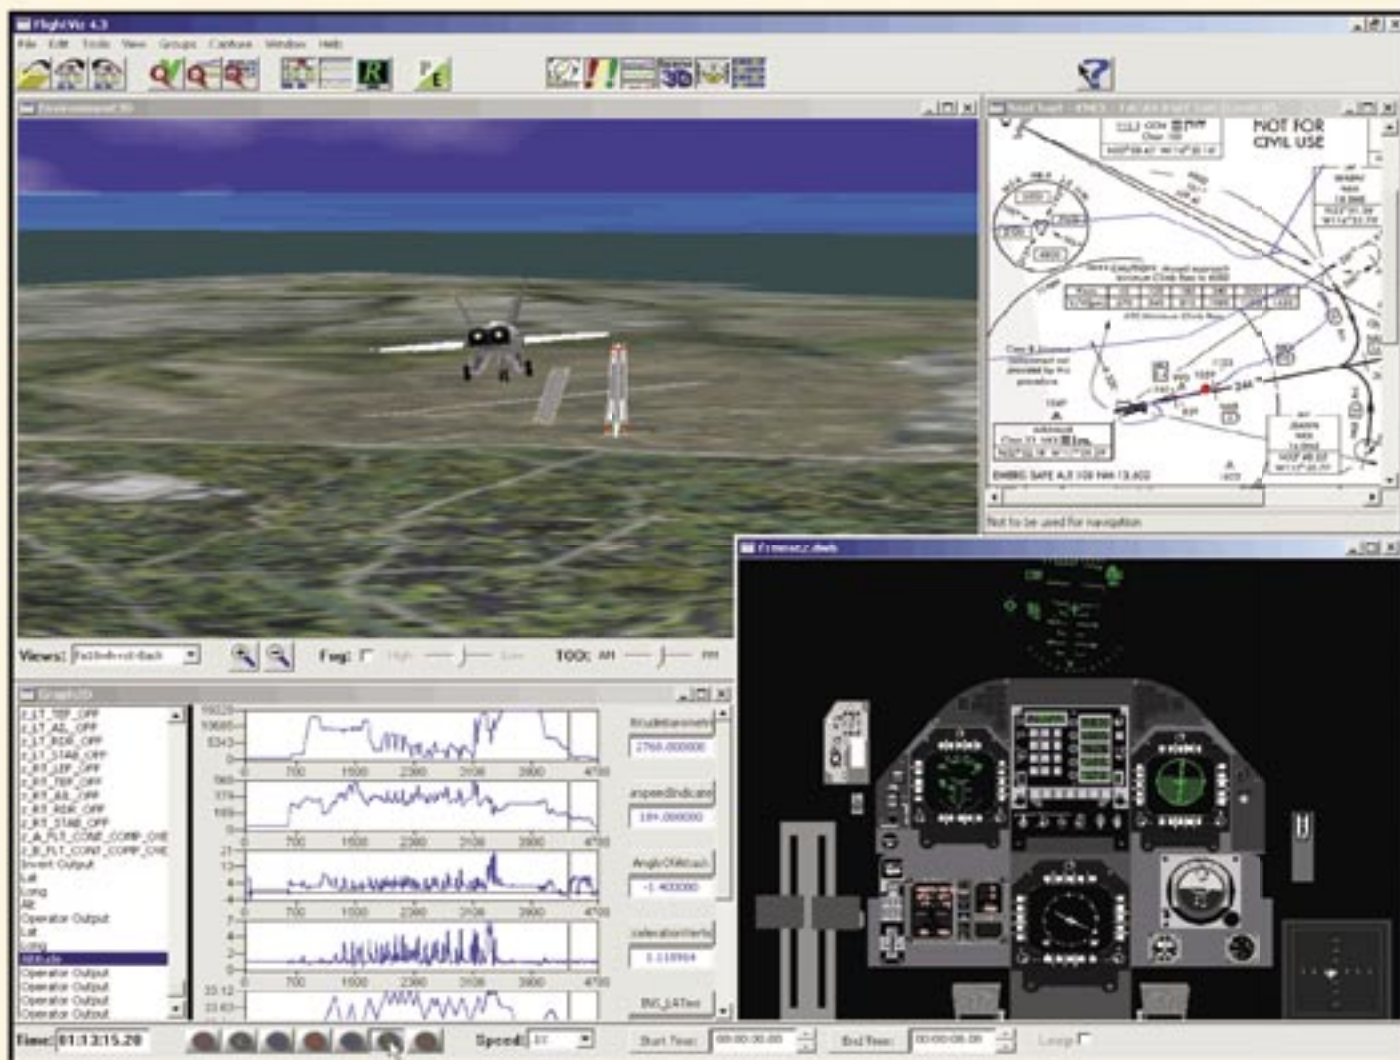
Playback of the mission, instrumentation, and flight performance is possible with MFOQA.

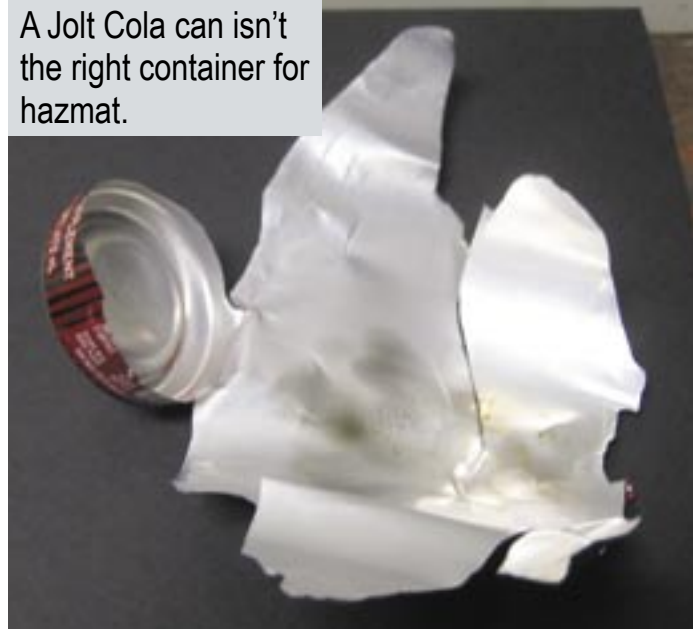
A Jolt Cola can isn't the right container for hazmat.

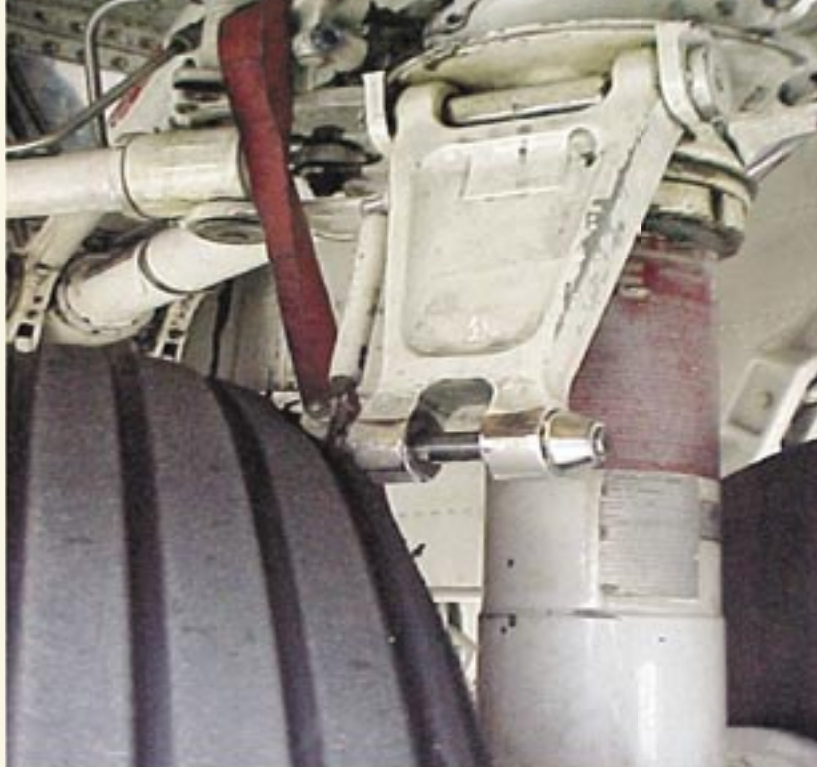
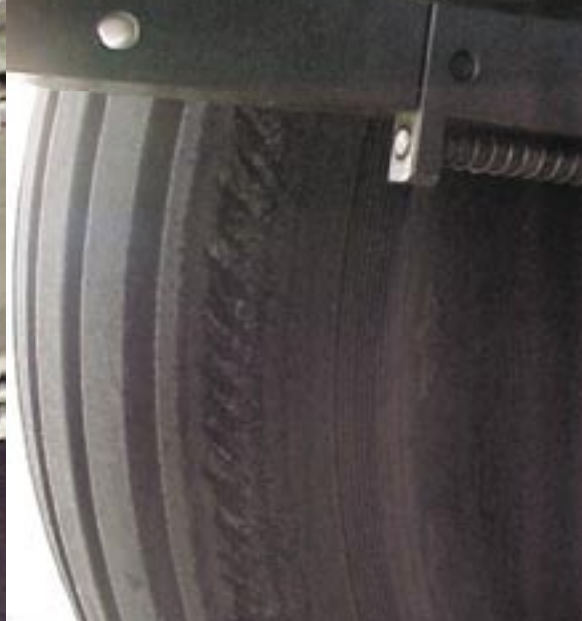
How much damage can be done when jacks fall? These photos show the damage, but it could have been worse.

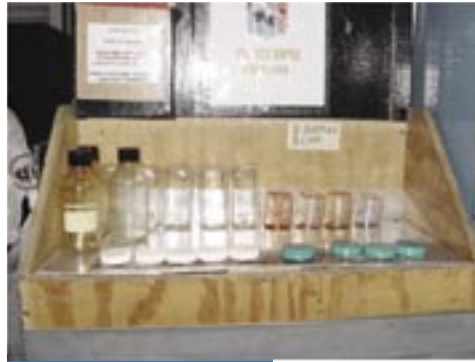
ECP bottle drain

Best Practice: We've seen several squadrons using a locally manufactured draining rack to drain
